Final Report

**Assessment and Remediation of Hazardous Waste
Contaminated Areas in and around M/s Union
Carbide India Ltd., Bhopal**

**Bhopal Gas Tragedy Relief and Rehabilitation Department
Govt. of Madhya Pradesh, Bhopal**

**National Environmental Engineering Research Institute
Nehru Marg, Nagpur - 440020
(www.neeri.res.in)**

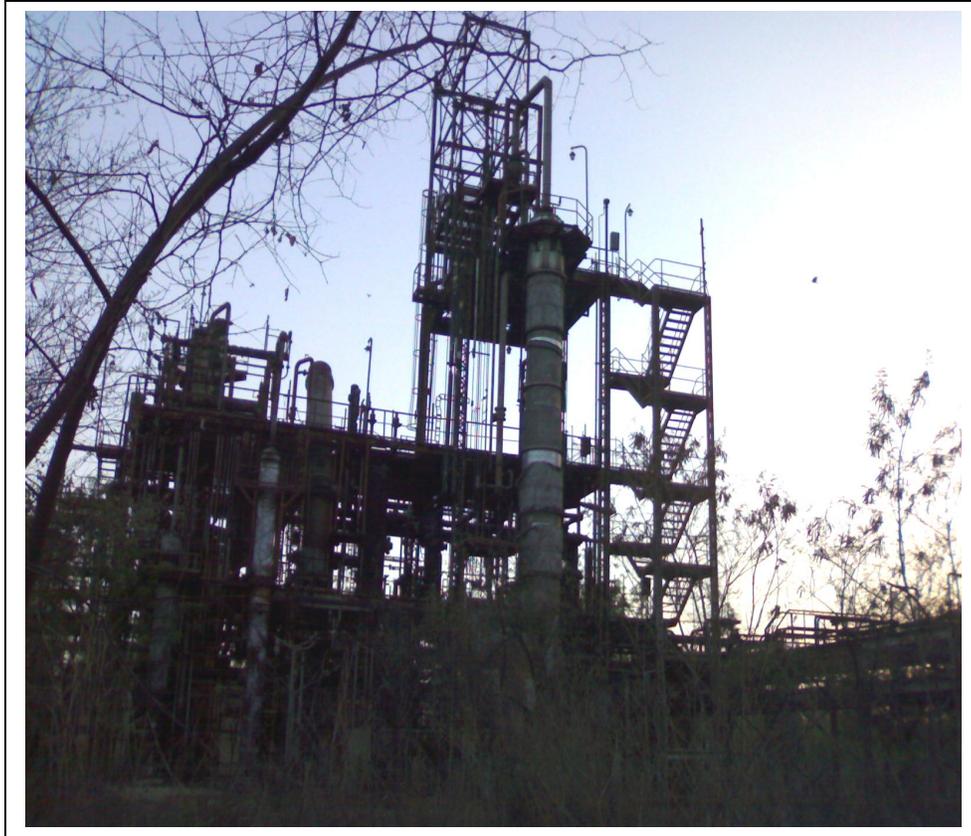
Plate 1: General view of UCIL plant

A detailed reconnaissance survey of the UCIL premises and the surrounding area was carried by NGRI and NEERI during the study. During the reconnaissance survey, the NGRI-NEERI teams collected background information on products, processes, raw materials used and the wastes generated/disposed off by UCIL during its operation. Teams also surveyed the existing dumps located within the UCIL premises as well as waste disposal facilities located outside UCIL premises (solar evaporation ponds and secured landfill). **Plate 1** depicts the general view of UCIL Plant.

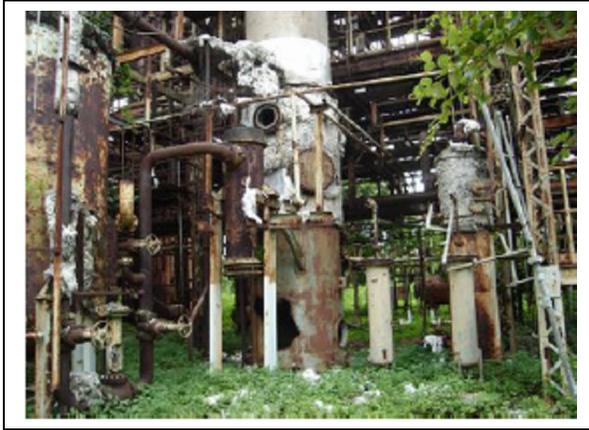
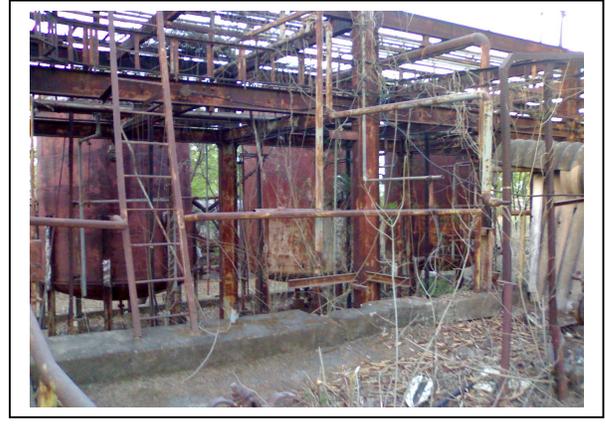
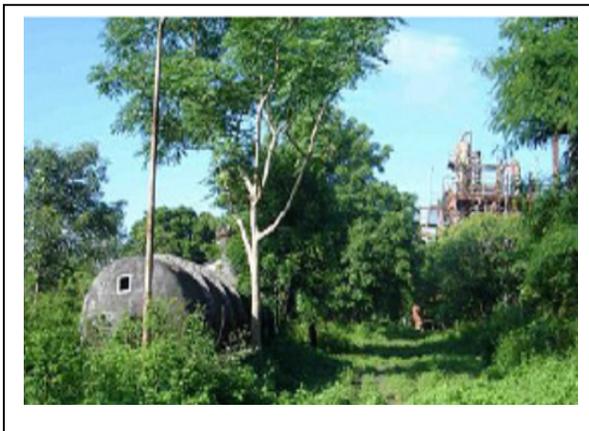
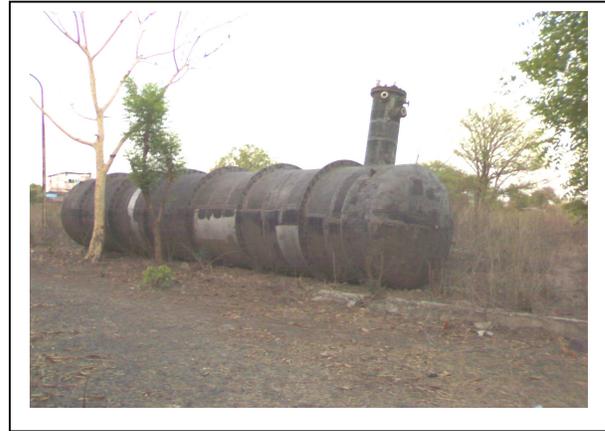
Plate 2: Plant and machinery in dilapidated conditions

During the reconnaissance survey of the UCIL premises, the NGRI-NEERI team observed remains of various manufacturing plants, machinery, buildings and sheds within UCIL premises. Most of the plants and machinery was in dilapidated conditions and appeared to be contaminated (**Plate 2**).

- It was also observed during the reconnaissance survey that various plants, buildings, sheds and equipments located within UCIL premises are in dilapidated conditions and appeared to be contaminated. It is recommended that decontamination and decommissioning of these items should be taken by BGTRRD on priority, as per the plan delineated by IICT, Hyderabad. **These activities must be completed prior to the commencement of full scale soil and groundwater remediation as these activities may further result in contamination of soil and groundwater.** As informed by IICT, about 300 MT of waste is likely to be generated during decontamination and decommissioning activities. These wastes shall also be disposed off at an on-site secured landfill facility as per the plan delineated under long-term measure.

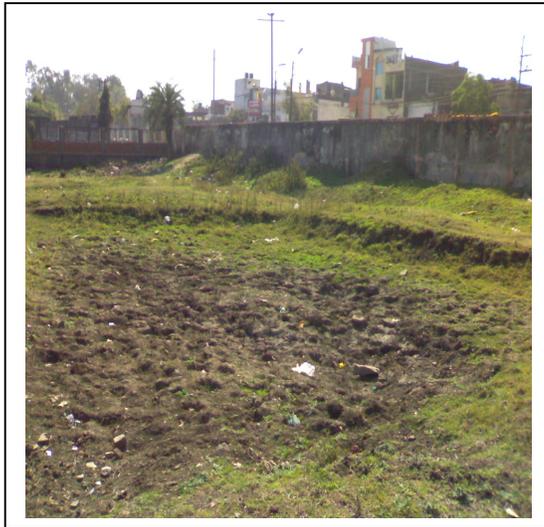
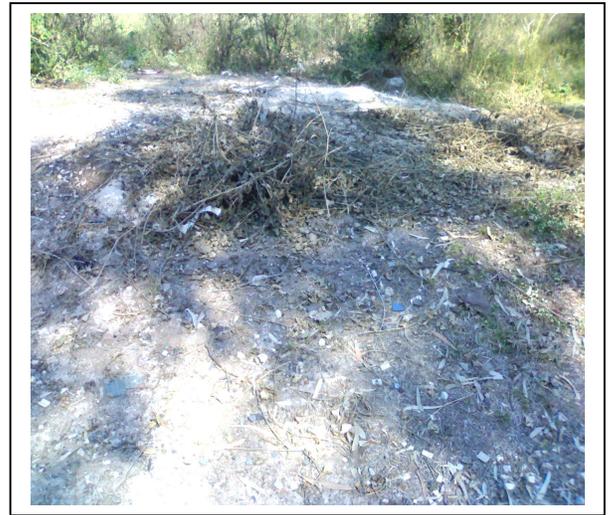
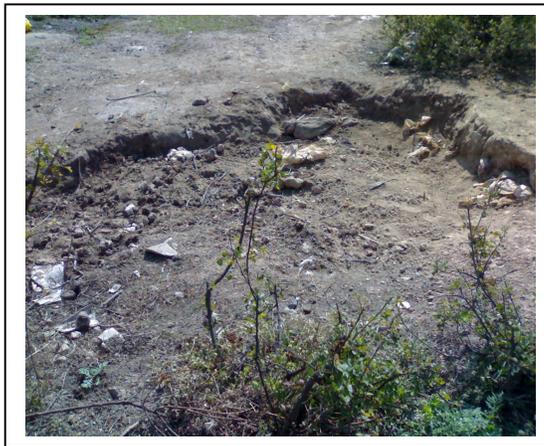
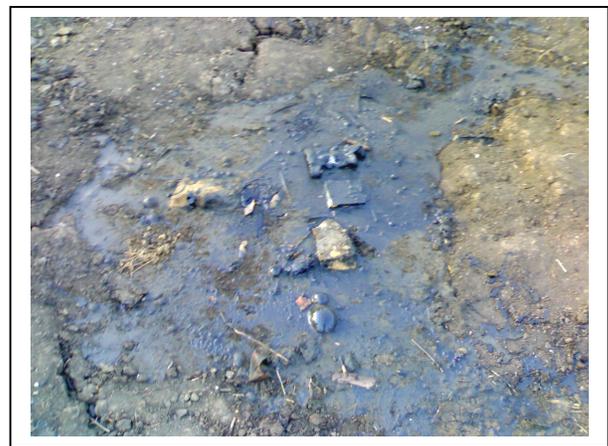
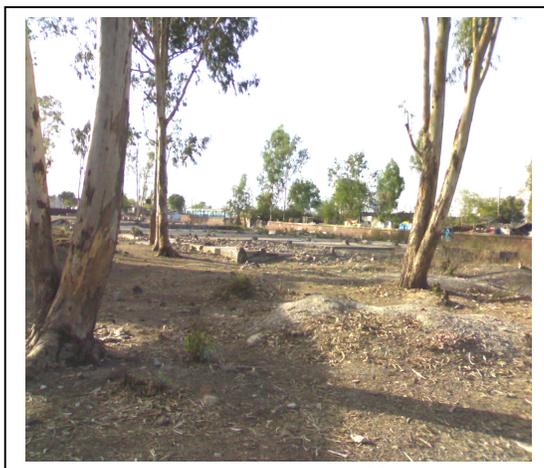
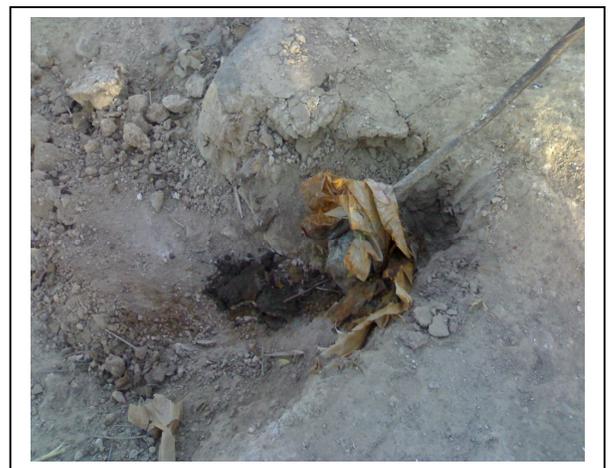
Plate 3: Existence of dumps within UCIL premises

The reconnaissance survey of the open areas within plant premises revealed existence of a number of dumps, especially, in disposal area I and disposal area II which give very pungent smell of pesticides. The existence of dumps within UCIL premises indicated that the excavation and recovery of dumped material from the dumpsites, carried out by MPPCB through M/s Ramkey Ltd., is still incomplete (**Plate 3**).

- As mentioned in Section 2.3, excavation and recovery of dump material from the disposal areas by M/s Ramkey Ltd was incomplete as huge quantities of wastes (tarry wastes, off-specification products) still exist at various locations within UCIL premises. It is, therefore, recommended that these dumps should be carefully excavated and the excavated material should be properly collected, stored. The incinerable material, from such dumps shall be disposed off at an authorized TSDF at Pithampur in Madhya Pradesh, in accordance with the prevailing hazardous waste management rules and regulations. The non-incinerable wastes being larger in quantity shall be disposed off at an on-site secured landfill facility as per the plan delineated under long-term measure.

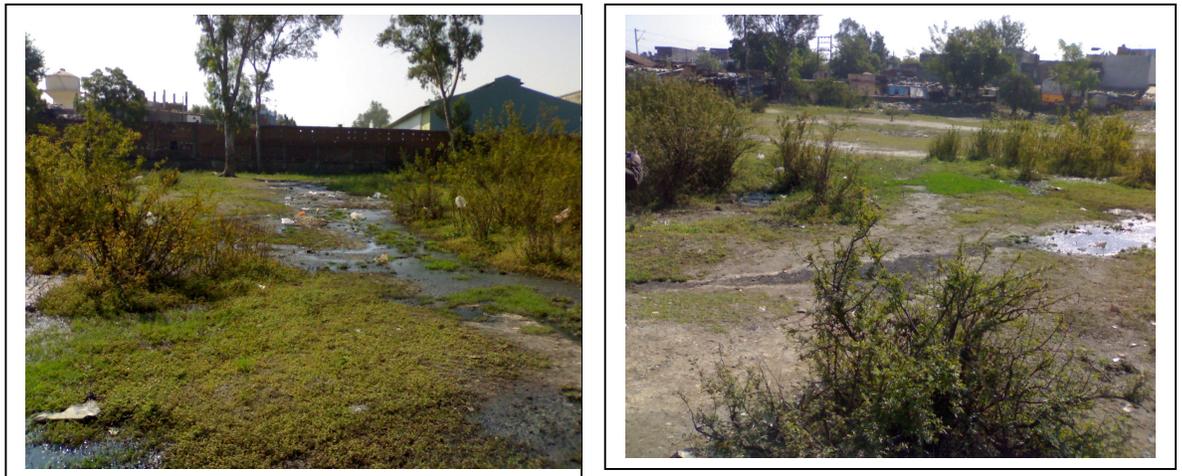
Plate 4: Wastewater released by the hutments/industries in UCIL

The boundary wall of the UCIL premises was found to be broken at many places and this provided an easy access to the people living around the premises. Some of the open areas of the premises were also used by children as a play ground. The UCIL premises were surrounded by thickly populated hutments. The wastewater released by hutments and adjacent industries was found to be accumulated at many places within UCIL premises **(Plate 4)**.

- As discussed in Section 2.3, the boundary wall of the UCIL premises is broken at many places providing easy and uncontrolled access to nearby residents. Moreover, the SEP and the abandoned secured landfill area is also un-guarded and found to be damaged. BGTRRD is therefore advised to take immediate steps for ensuring proper fencing and security to these areas for preventing unauthorized access and use of these areas by public.
- It is recommended that as an immediate short-term measure, the five contaminated wells as specified in previous chapter should be immediately sealed so as to prevent use of water from these wells for any purpose by the residents.

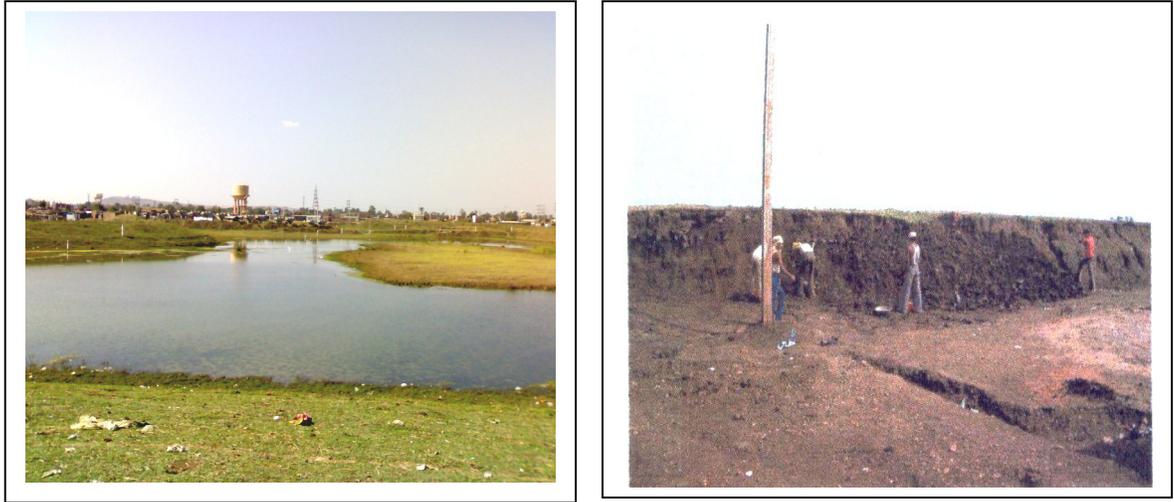
Plate 5: Improper management of SEP and abandoned landfill

The reconnaissance survey of the SEP area outside the UCIL premises revealed existence of one SEP which was partially filled with water. The SEP was un-guarded and was found to be littered with night soil and other domestic refuse **(Plate 5)**.

During the reconnaissance survey, it was learnt that out of three SEPs, two were converted into a secured landfill for the disposal of dried sediments from SEPs. The high density polyethylene liners from SEP and secured landfill were found to be damaged/removed during the reconnaissance survey.

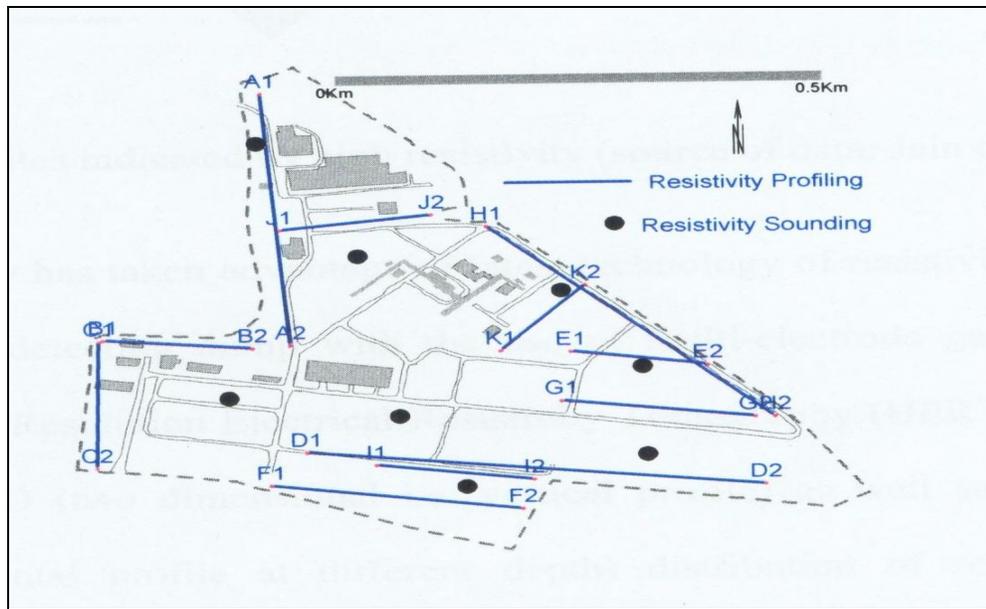
Fig. 3: Electrical Resistivity Profiling (ERP)

Among all the surface geophysical techniques for shallow subsurface prospecting, Electrical Resistivity Method is the most widely applied method. The electrical resistivity method can be classified in two categories viz. 1) vertical electric sounding (VES) and 2) electrical resistivity profiling (ERP). The VES is used for delineating vertical variations of the subsurface, whereas ERP is used to detect lateral variations (anomalies).

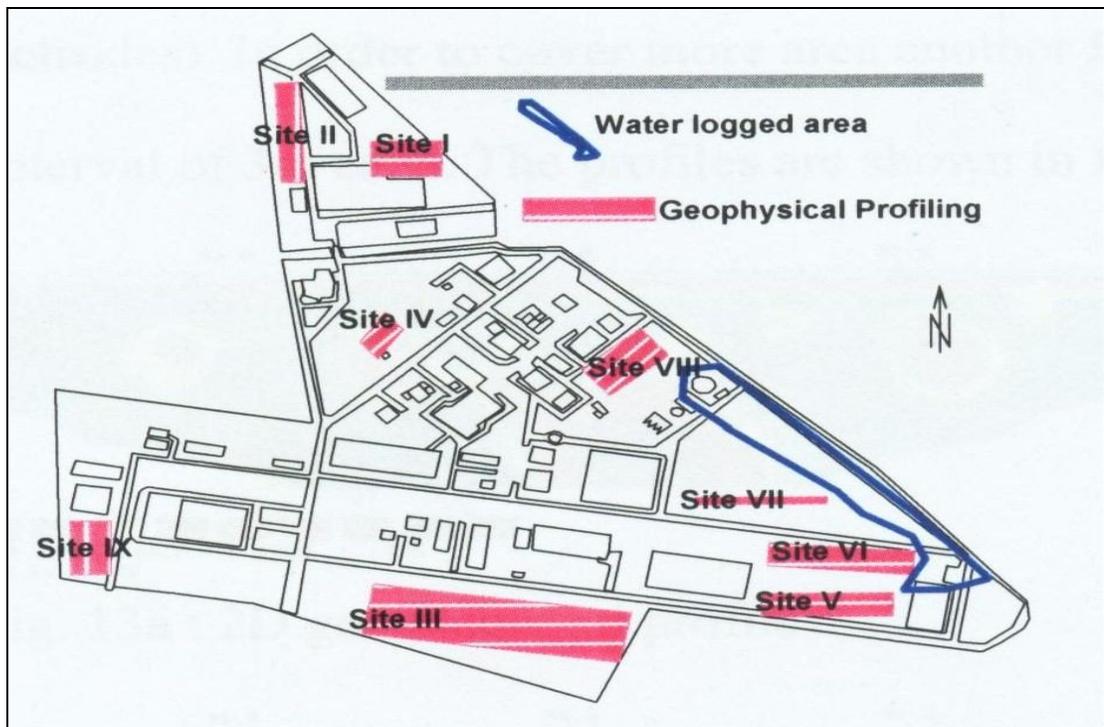
Fig. 4: Locations of HERT survey

The latest technology of resistivity imaging namely High Resolution Electrical Resistivity Tomography (HERT) was used by NGRI for obtaining two dimensional (vertical profile) as well as three dimensional (horizontal profile at different depth) distribution of resistivity of subsurface strata. An equipment, SAS4000 from ABEM, Sweden was used for the present study. The data were interpreted using RES2DINV (2005) software.

The HERT was carried out across the selected areas based on background information about the site as well as physical limitations at site (existence of concrete structures, sheds, bushes, water logging, roads etc). A total of nine sites within the UCIL premises were covered during the HERT survey. The locations of HERT survey are depicted in **Fig. 4**.

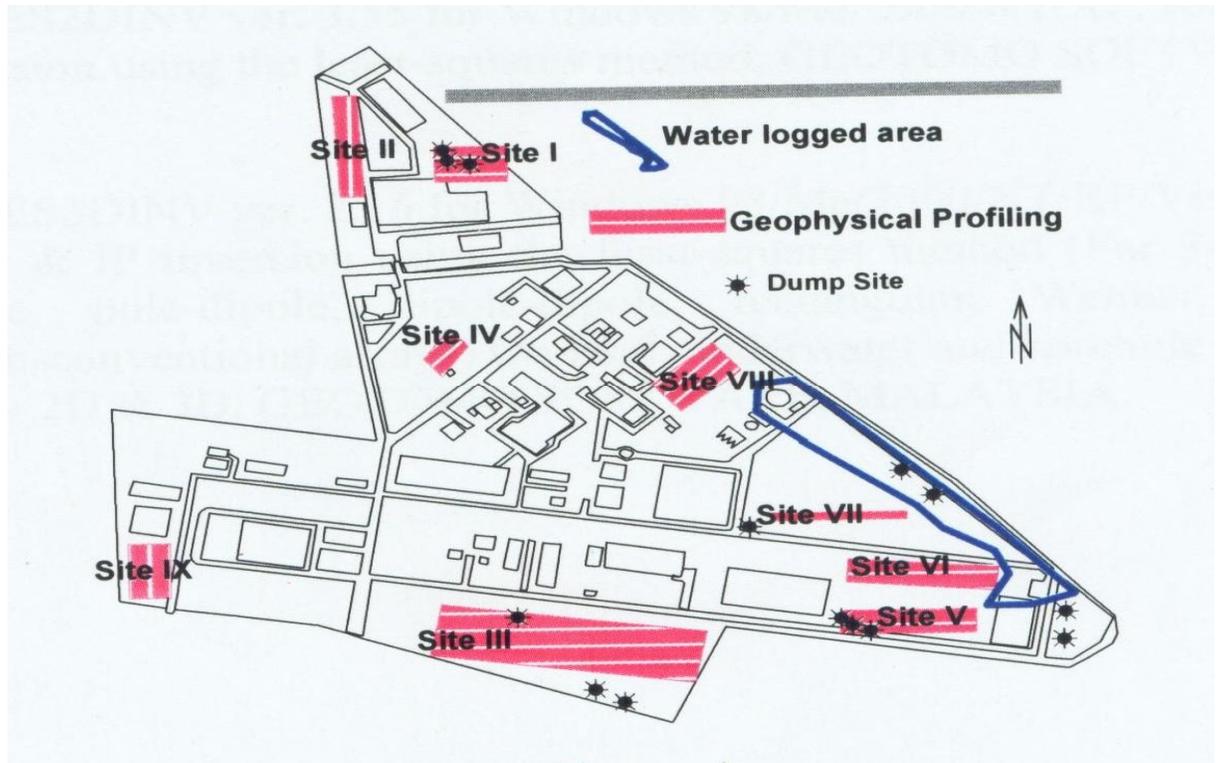
Figure 5: Locations of suspected dumps at UCIL premises

Site I : The site is situated in the northern part of the premises in front of Formulation plant (**Fig. 5**). The heaps of dumps were visible at the open space emitting pungent smell of pesticides. The HERT profiles were laid across the dump in EW direction. at an electrode separation of 1m so that the dumps are adequately covered.. A total area of 9m x 48m was covered at this site. It was observed that the dumps showed higher resistivity of the order of 100 to 300 ohm-m as compared to the resistivity of about 5 to 8 ohm-m for black cotton soil. The dumps were clearly demarcated in the profile with depth from few cms to about 1m.

Site IV: This site is situated in the open space close to tower (**Fig. 5**). Due to limitation of space, electrode spacing was restricted to 0.5m with total

profile length as 23.5m in NS direction. This area also showed the uniform low resistivity with no sign of any dump.

Site V: This site is situated in the area east of Police Post and the open space between Neutralization tank and SEP (Fig. 5). The SEP I and II were water logged as shown in Fig. 3 h, I and j, hence could not be covered. The SEP-I was filled with domestic waste from nearby settlements. The heaps of dump with strong smell of pesticides were visible along the road leading to SEP. The total area covered at this site is about 48mx14m. The resistivity profiles obtained in the area indicated existence of dumps up to a depth of about 0.7 to 1.3 m.

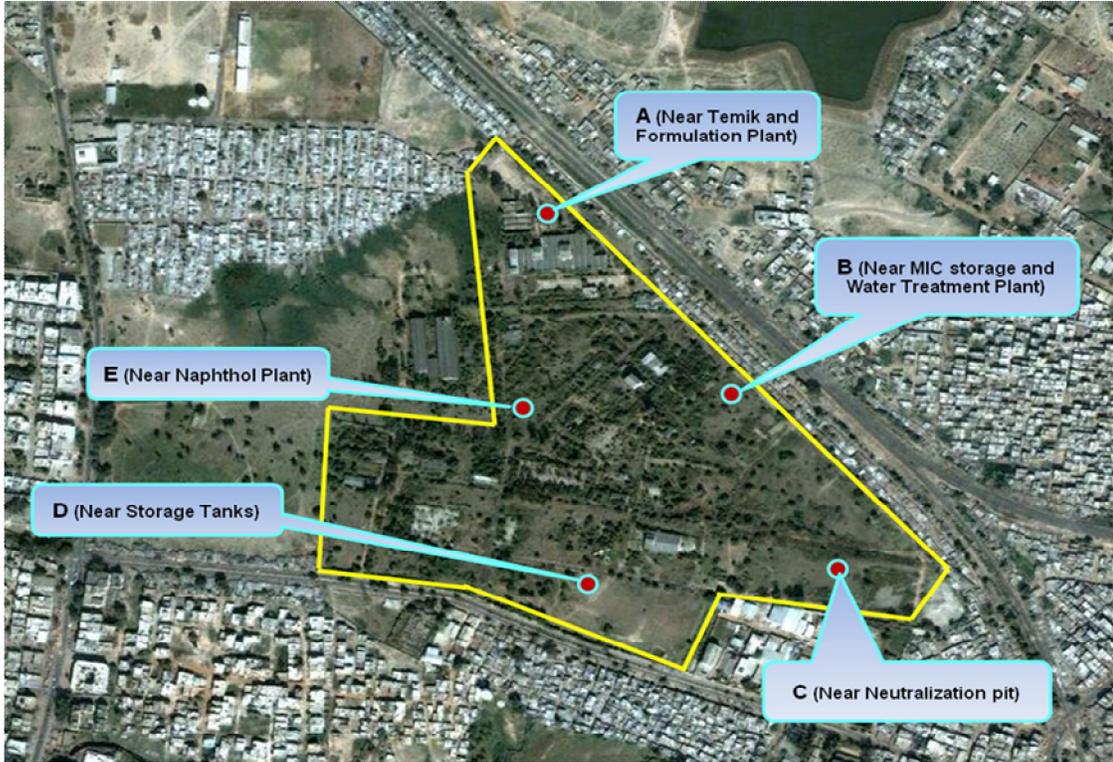
Figure 6: Location of sites selected for drilling within the UCIL premises

In order to confirm the observations made from geophysical investigations and to generate precise data/information on subsurface lithology within the plant premises of UCIL, drilling of test borewells was carried out by NGRI during January 2010. Total five sites were selected to carry out drilling. The selected sites for drilling are shown in **Fig. 6**. Lithologs were collected at different intervals during drilling. **Plate 6** depicts drilling of borewells. The lithological description of each site is depicted in **Fig 7 to 11**. A fence diagram based on the lithologs is shown in **Fig. 12**.

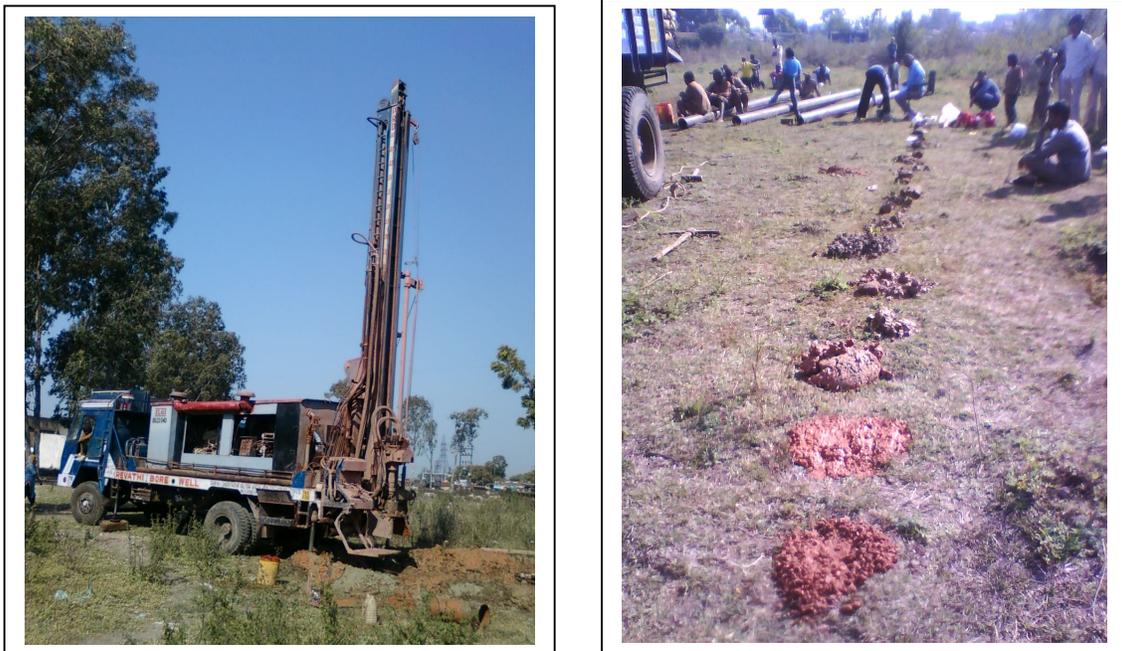
Plate 6: Drilling of borewells within UCIL premises

Based on the data generated during drilling of test borewells it was observed that the weathered basalt is overlain by black silty clay of 10 to 17 m below ground surface. The basalt is further overlain by yellow silty clay and its depth varies from 22 to 25 m. The underneath formation is sandy alluvium with pebbles which is saturated with water forming aquifer. The thickness of this aquifer varies from 0.7 to 4.6m being thickest in eastern part of UCIL premises. Water was struck at about 25 m below ground surface and risen to about 8.5 to 14 m indicating that aquifer may be in confined condition. The entire bore wells were screened only in the lower part against aquifer and remaining portion is sealed with iron casing so as to prevent cross contamination of aquifer.

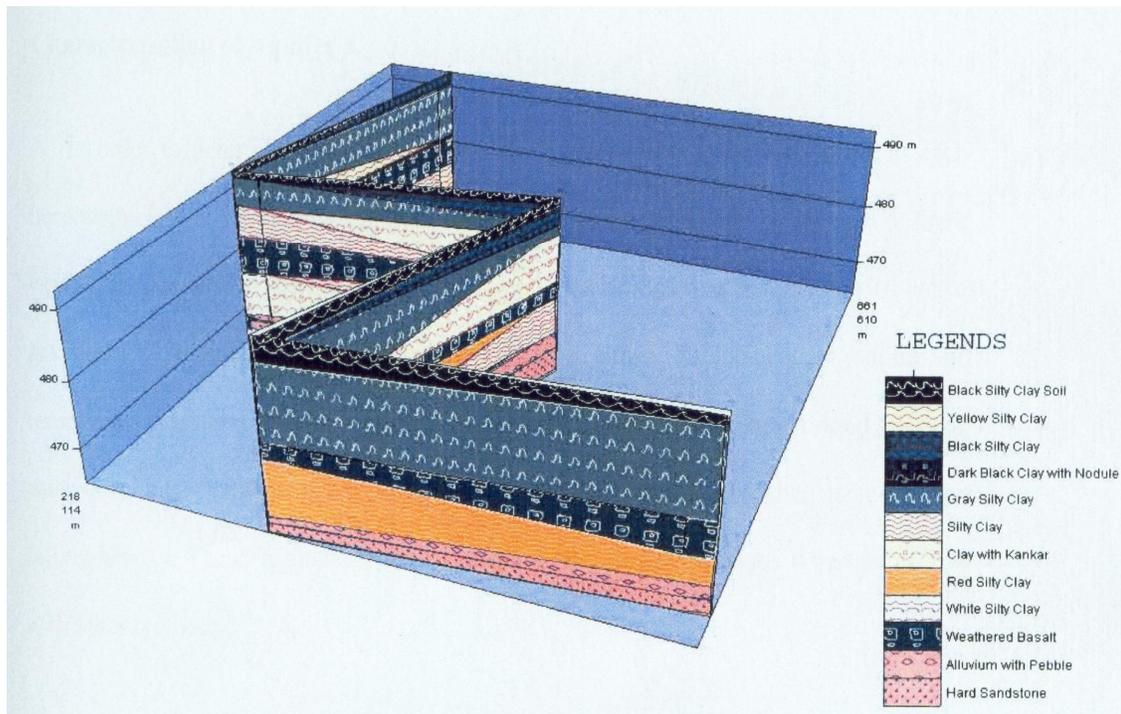
Figure 12: Fence diagram showing geological strata at UCIL premises

It may be concluded from the hydrogeological studies that entire area of UCIL premises is occupied by a thick layer of black silty clay and yellow silty clay upto a depth of about 22 to 25 m below ground level. The groundwater occurs in sandy alluvium with pebbles at a depth of around 25m below ground surface under confined condition. The groundwater flow direction in and around the UCIL premises was in south-east direction which could change with time. It was also reported by NGRI that there existed a subsurface elevation or mound near the central part of the UCIL premises, which diverted the subsurface water flow in north-east or south-east directions depending on the approach of the flow.

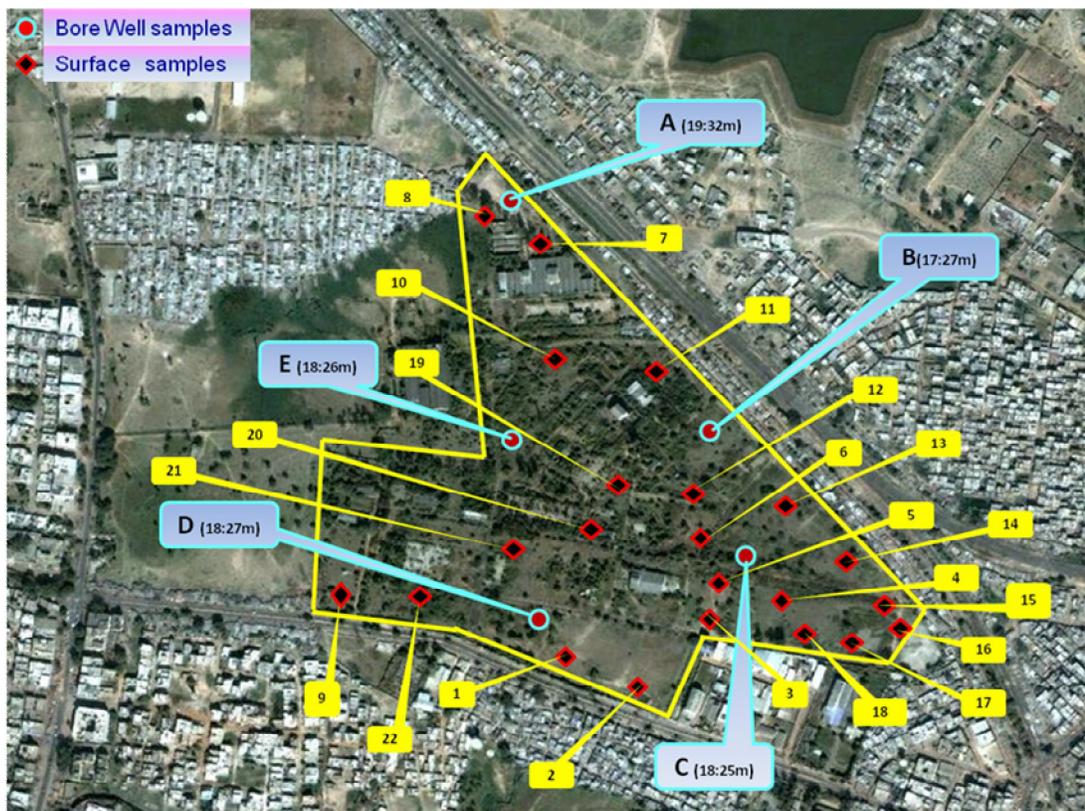
Figure 13: Locations of soil samples collected within UCIL plant premises

The boreholes were drilled by NGRI adjacent to the suspected contaminated areas so as to prevent cross contamination of aquifer. Hence, additional 27 surface and subsurface (30 cm deep) soil samples were also collected from the exact locations of the suspected contaminated hot spots within UCIL premises (**Figure 13, Table 8**).

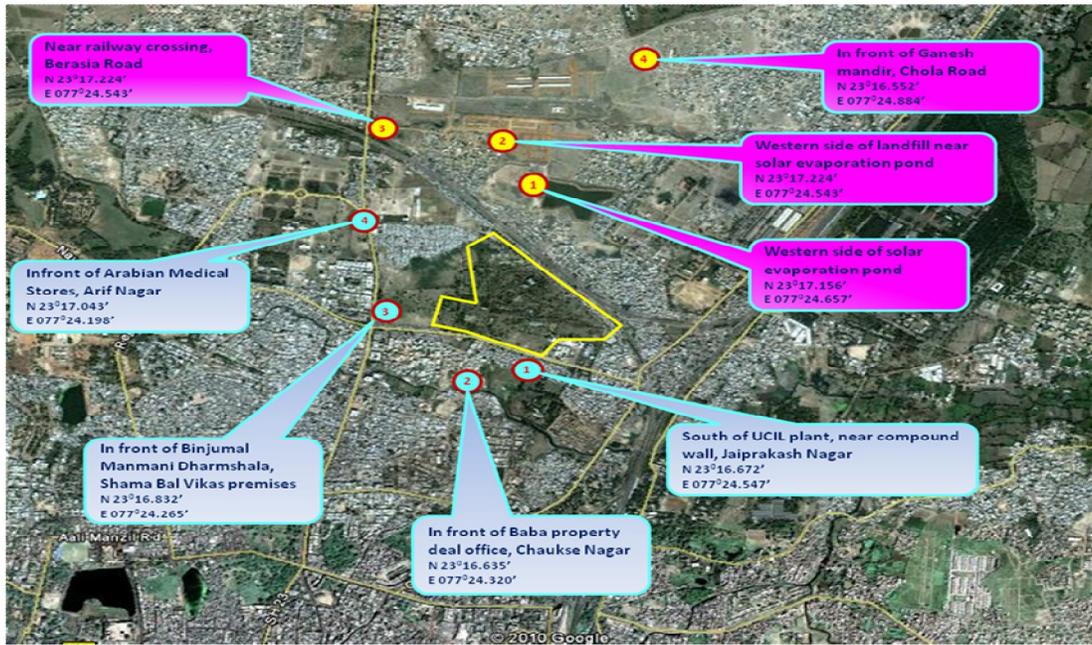
Figure 14: Locations of upstream and downstream soil samples collected outside the UCIL premises

In addition to the boreholes and suspected contaminated hotspots, soil samples were also collected from eight different locations outside the UCIL plant premises considering the ground water flow direction, which is generally towards the north-east or east direction as reported in previous studies. The soil samples at these locations were collected at three different depths (surface, 30 cm deep and 60 cm deep). Thus, total 24 soil samples were collected outside UCIL premises. Out of these eight locations, four locations were in upstream (South-West) of UCIL and four

locations were in downstream (North-East) of UCIL. The sampling locations are depicted in **Figure 14** and details are listed in **Table 9**.

The results of analysis of soil samples collected downstream of UCIL are presented in **Tables 11 to 18**. Out of these four samples, soil sample collected near solar evaporation pond (**Fig. 14**) showed the presence of aldicarb, carbaryl, α -naphthol and β -HCH. The concentrations of these contaminants were 8.15, 6.88, 3.51 and 2.55 mg/kg respectively. The concentration of mercury at this location was found to be 0.30 mg/kg. Another soil sample collected near the western side of secured landfill adjacent to solar evaporation pond revealed traces of β -HCH isomer (0.40 mg/kg). The concentration of mercury at this location is about 0.33 mg/kg. The contamination at these locations may be attributed to unscientific management of landfill and solar evaporation pond (as stated in Section 2.3). As reported in previous studies, the area occupied by SEP and landfill is about 14 hectares. Since no drilling was carried out by NGRI in

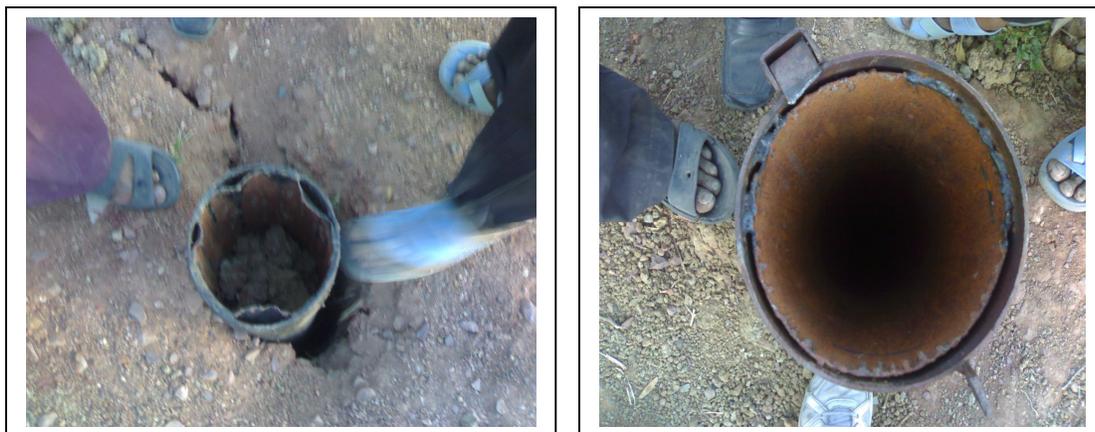
Plate 7: Tampered/broken borewells within UCIL premises

The confirmatory sampling of these borewells was attempted by NEERI in May 2010. However, during the visit, all the borewells constructed by NGRI were found to be broken, tampered and filled with unknown materials. Hence, repeat sampling could not be done for these borewells.

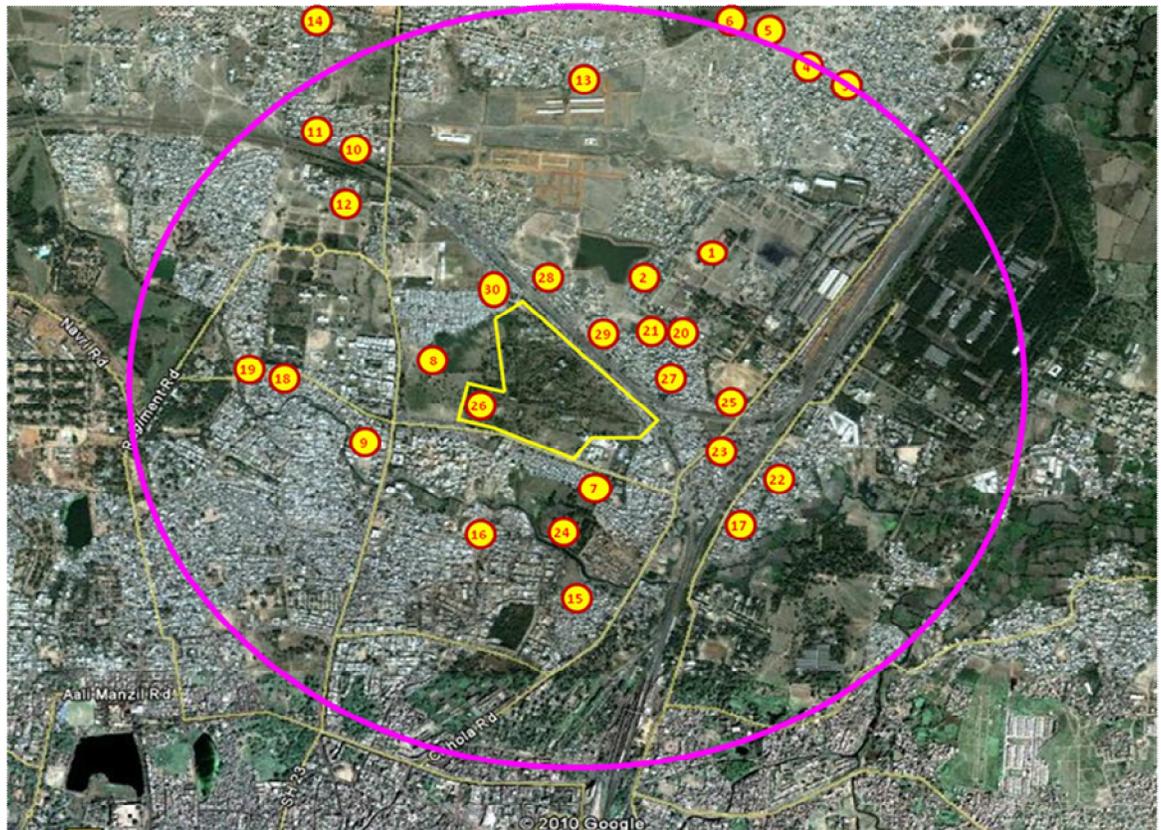
Figure 15: Locations of groundwater samples collected around UCIL premises

In addition to the above mentioned groundwater samples, samples were also collected from the existing sources (dug wells, bore wells and hand pumps) around the UCIL premises. The groundwater sampling was done considering the groundwater flow direction, which is in general towards North-East. The locations and details of groundwater samples collected around the UCIL plant are presented in **Figure 15** and **Table 10**. The samples were preserved and transported as mentioned in the previous section.
